Safer Alternatives to Copper Antifouling Paints: Nonbiocide Paint Options

Prepared for:
Cal/EPA's Department of Toxic Substances Control and
U.S. Environmental Protection Agency Region IX

Prepared by:
Katy Wolf
Institute for Research and Technical Assistance

February 2012

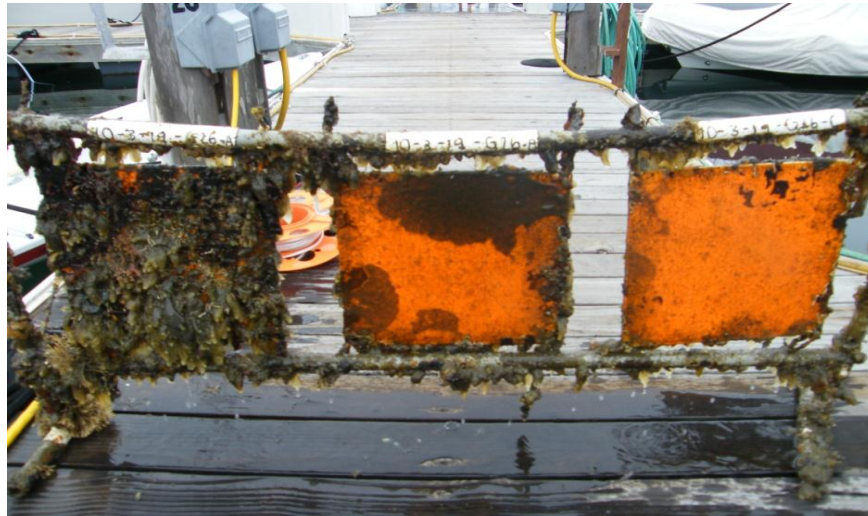
The same situation was apparent in the case of virtually all of the hard nonbiocide paints. Cleaning with the carpet could not adequately remove the fouling no matter how long the cleaning went on. Furthermore, aggressive and prolonged cleaning with the carpet would simply imbed the fouling into the coating rather than remove it. The panels would end up stained with fouling that could not be completely removed. Figures 3-8 and 3-9 show pictures of the three panel assemblies of hard nonbiocide paints with heavily stained middle panels. In addition, some of the coatings had to be scrubbed so hard that the coating was damaged. Cleaning with a more aggressive tool, like an abrasive pad, could remove the paint much more effectively. In some cases, however, even the more aggressive pad did not adequately remove the fouling and a periodic power tool cleaning would have helped considerably.

Figure 3-8. Hard Nonbiocide Paint with Stained Middle Panel

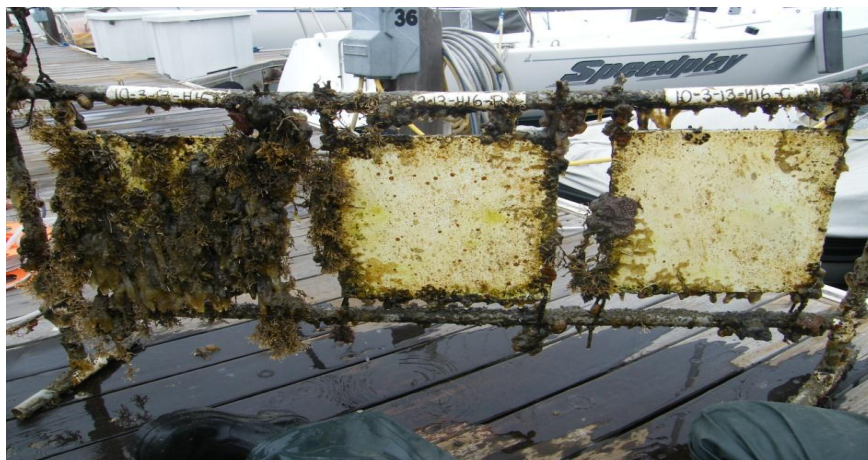
Figure 3-9. Another Hard Nonbiocide Paint with Stained Middle Panel

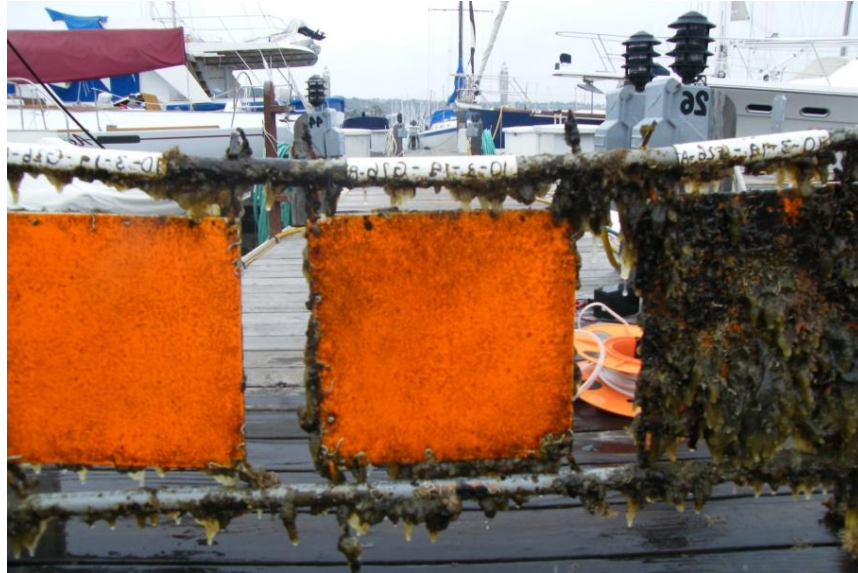
This paint, a typical hard nonbiocide paint, was very stained by the end of the testing period. It would likely require frequent cleaning with a power tool to perform well. Figure 3-11 shows the panels containing this paint near the end of the testing.

Figure 3-11. Crystal Marine Pro Paint During Panel Testing

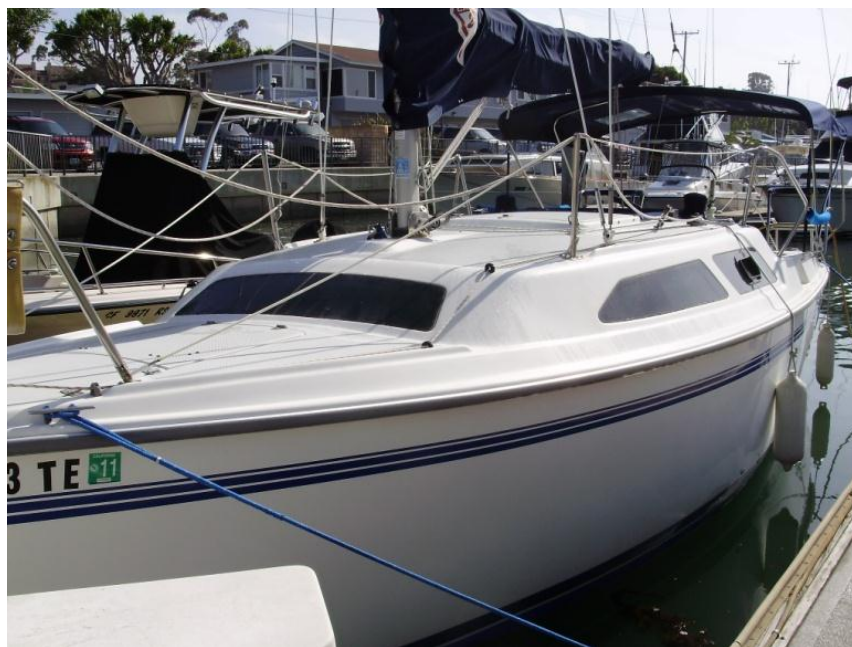
IRTA inspected the boat at the end of April, 2011 with the paint supplier when the paint had been on the boat for nine months. The supplier dived in the water and examined the boat hull and its appearance was very good. A picture of the boat during this inspection is shown in Figure 5-3. IRTA and the supplier had provided cleaning guidance to the diving company that maintains the boat. The company was told to clean the boat with gentle tools like a soft carpet and to maintain a schedule of approximately 15

Figure 5-3. Auerbach Boat at One Year Inspection.
