Safer Alternatives to Copper Antifouling Paints: Nonbiocide Paint Options

Prepared for:
Cal/EPA's Department of Toxic Substances Control and
U.S. Environmental Protection Agency Region IX

Prepared by:
Katy Wolf
Institute for Research and Technical Assistance

February 2012

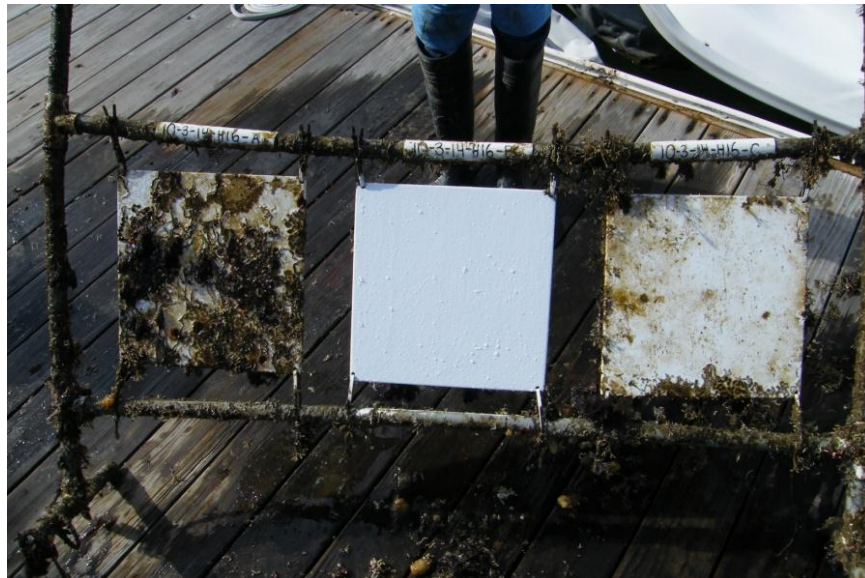
Figure 3-4. XP-A101 Paint During Panel Testing

This paint is also a silicon based foul release paint with a fluoropolymer added. The panel testing sheets indicate that it performed better than the other Klear N' Klean formulation in the panel testing. The two panels that were cleaned were cleaned readily and the coating condition was good until the last inspection when some scratches were noted. A picture of the three panel assembly in January 2011, about halfway through the test period, is shown in Figure 3-4. Again, because the paint includes the ingredient which has been removed from the market, it is not a candidate for boat testing. Petit, the paint supplier, did reformulate the paint with a new fluoropolymer ingredient and the reformulated paint which has the same name was selected for boat testing.

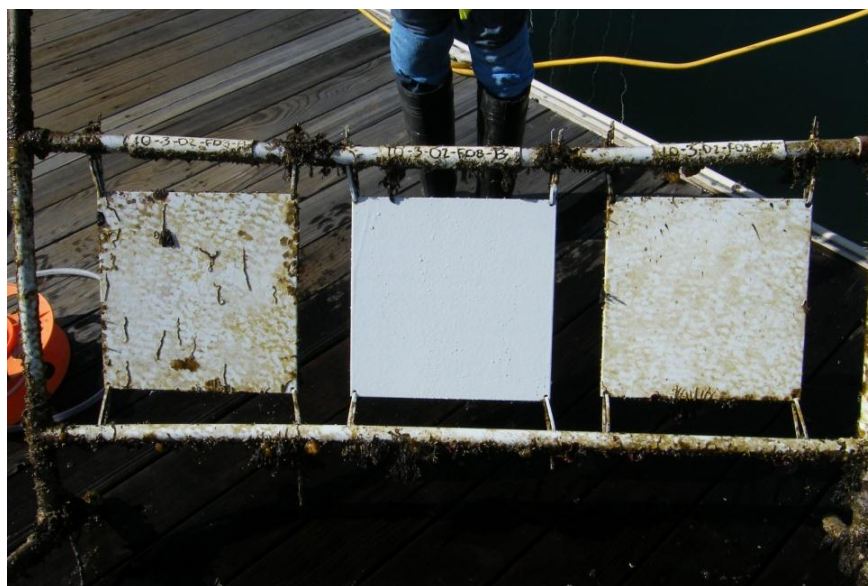
Figure 3-5. Sher-Release Paint During Panel Testing

Sher-Release is a silicon based foul release paint and is classified as a soft nonbiocide paint. The Appendix A panel testing data sheets for this paint show that, in general, the first panel (called NC for no clean in the data sheets) had very good results for the fouling ratings and coating condition. The same is true of the values for the panel cleaned using the standard carpet method (called SC in the data sheets). The one exception is that there are 5s in two of the columns for June 21, 2011 inspection. All the other values in the table and all the values for the manufacturer specified cleaning methods panel (called MC in the data sheets) are 1s and 2s. The 5s are likely to be incorrect data input numbers.

This paint did very well in the panel testing. Even the fouling ratings on the no clean panel and the two other panels prior to cleaning are low. The cleaning ratings are all low and the coating condition ratings are all low. A picture of the three panel assembly in January 2011 is shown in Figure 3-5. This paint was selected for boat testing because of its excellent performance in the panel testing. A Material Safety Data Sheet (MSDS) for the product, called Fujifilm Surface Coat Part A-Black, is shown in Appendix B.

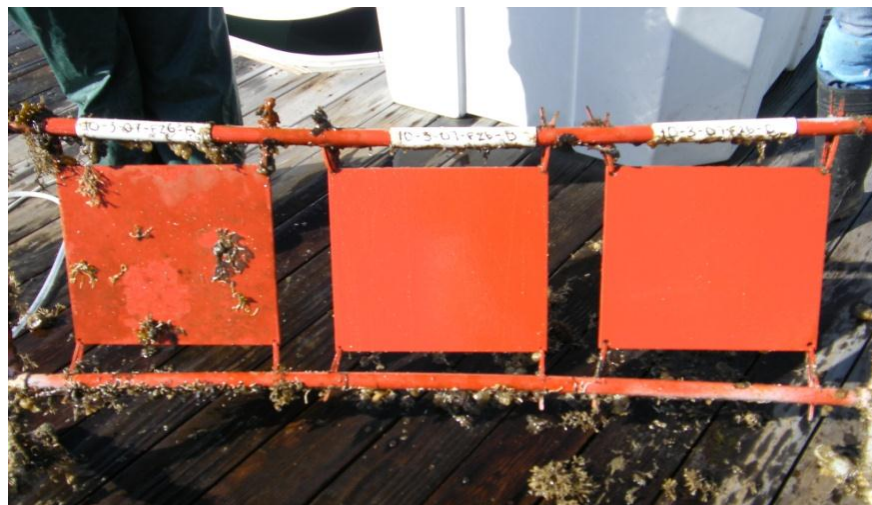
Figure 3-7. XA 278 Paint During Panel Testing

The panel testing data show that the fouling ratings on all three panels are very low for XA 278 which means the fouling levels are very good. Cleaning the panels was accomplished easily with soft tools. The company indicated the soft side of a sponge should be used and it readily removed the small amount of fouling that was present. The coating condition of all the panels was good. A picture of the three panel assembly for this paint in January 2011 is shown in Figure 3-7.

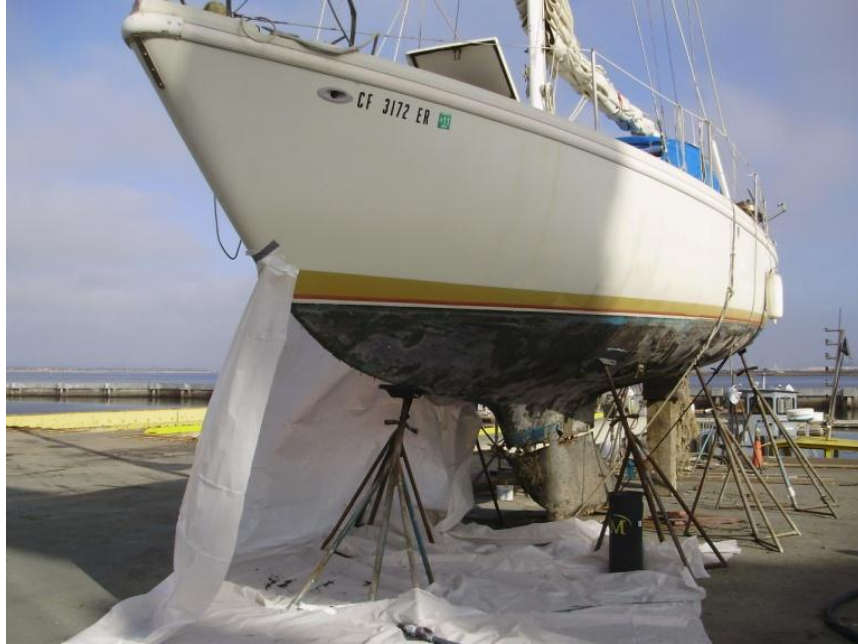
Figure 4-4. Boat Used for Stripping Test

The results of the testing are qualitative and limited since the technologies were used to strip patches of a boat with old copper paint rather than an entire boat. Figure 4-4 shows the boat that was used for the stripping tests. All three of the technologies were able to strip the copper antifouling paint from the boat hull. DTSC staff attended the demonstrations and took samples of the spent media and/or coating residue when each of the three methods was tested.

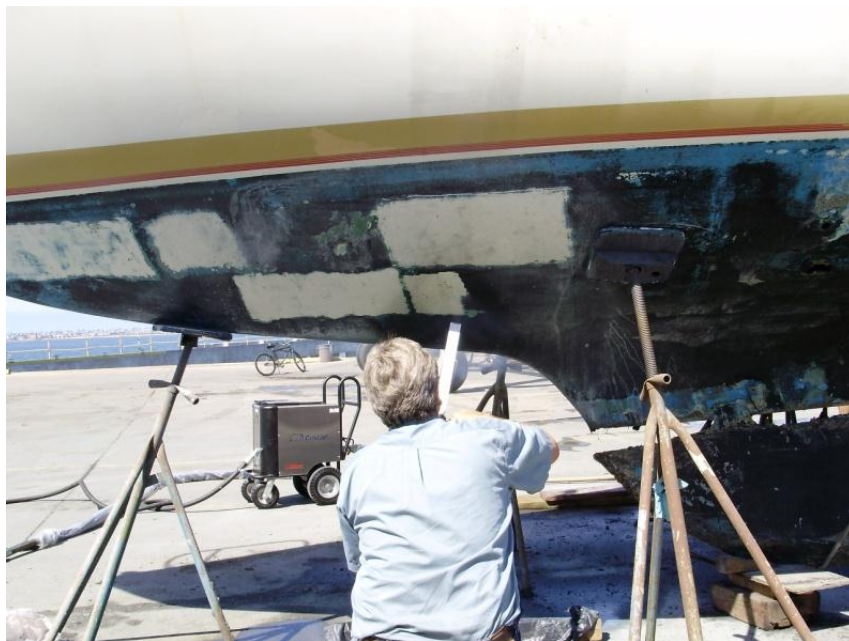
Figure 4-5. Stripping Tests at Marine Group

strip the patch. The dry ice blasting system supplier stripped three patches. The first patch required 3 minutes and 10 seconds. The second and third patches required 2 minutes and 10 seconds and 1 minute 50 seconds respectively. For the second and third patches, the supplier tried to strip more quickly and, in fact, he was able to shorten the time considerably when he tried to do so. A more practiced supplier could reduce the time further and the time on the Farrow system stripping might be shortened considerably as well if more effort were made to strip more quickly. Pictures of the stripping are shown in Figure 4-5 and 4-6.

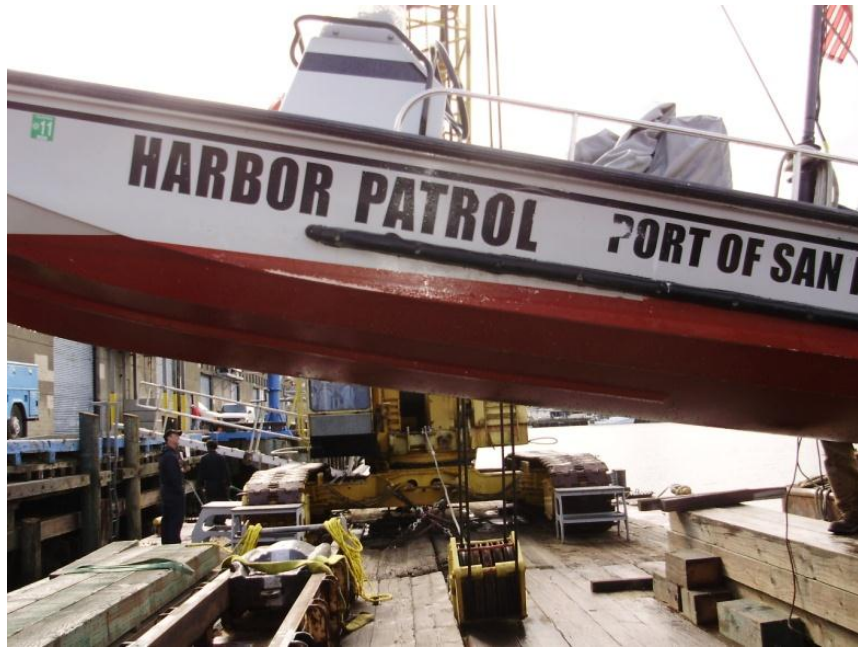
Figure 5-6. Port of San Francisco Boat Suspended by Crane

April, some months after it had been launched. The Port arranged for the boat to be lifted out of the water on a crane so the bottom could be inspected. Figure 5-6 shows the boat suspended by the crane. The boat had not been used during the period and there were small barnacles on the hull. These are shown in Figure 5-7. The boat was usually driven at fairly high speed and it was taken out for a period and the bottom was inspected again to see if the fouling remained. Figure 5-8 shows the hull after the boat was driven at high speed; it shows that nearly all the fouling was removed during normal use. This

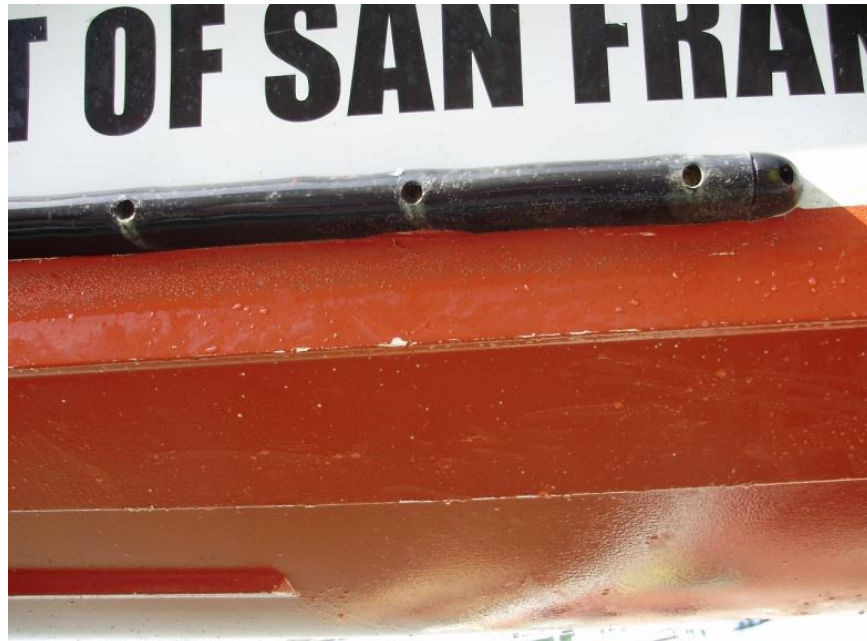
Figure 5-8. Port of San Francisco Boat After it was Driven at High Speed

indicated that the boat may not need diver maintenance if it is periodically driven at high speed. The Port agreed to have a diver inspect the boat periodically and perhaps remove any fouling with a soft cloth.

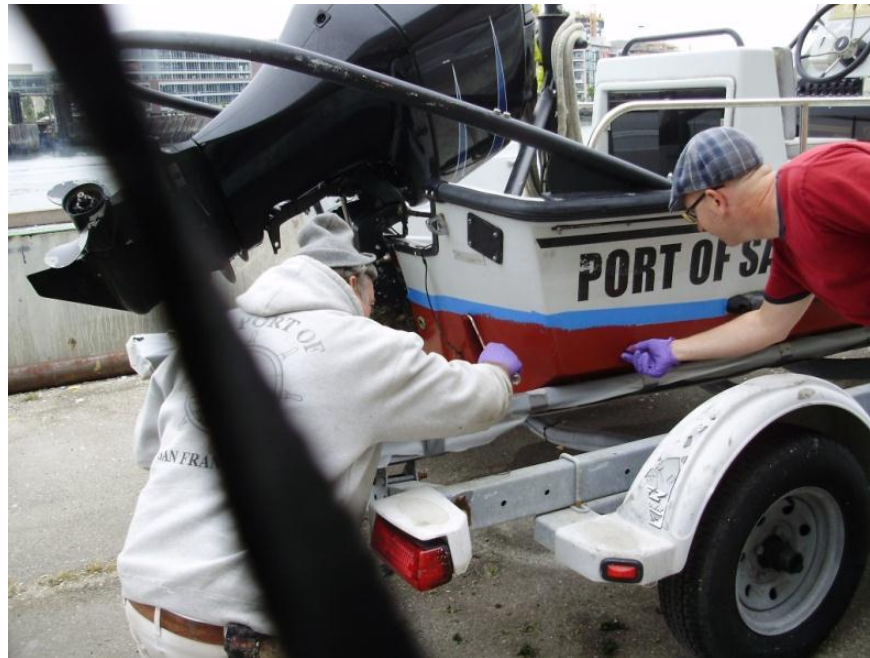
During the boat inspection, there was also evidence that the coating had been damaged at the waterline, particularly on one side of the boat. It may have been damaged by rubbing against the dock. The team decided to pull the boat out of the water again at a later time to touch up the paint on the waterline. The supplier and IRTA decided to use the same coating, this time with an added hardener; this version of the coating had been applied to another boat since the first paint application of the Port boat (see Fish and Game boat description below). Figure 5-8 above shows the Port boat waterline damage and Figure 5-9 shows the boat during the paint/hardener touchup operation. The boat was launched again the first week of August 2011.

Figure 5.9. Port of San Francisco During Paint/Hardener Touchup Operation

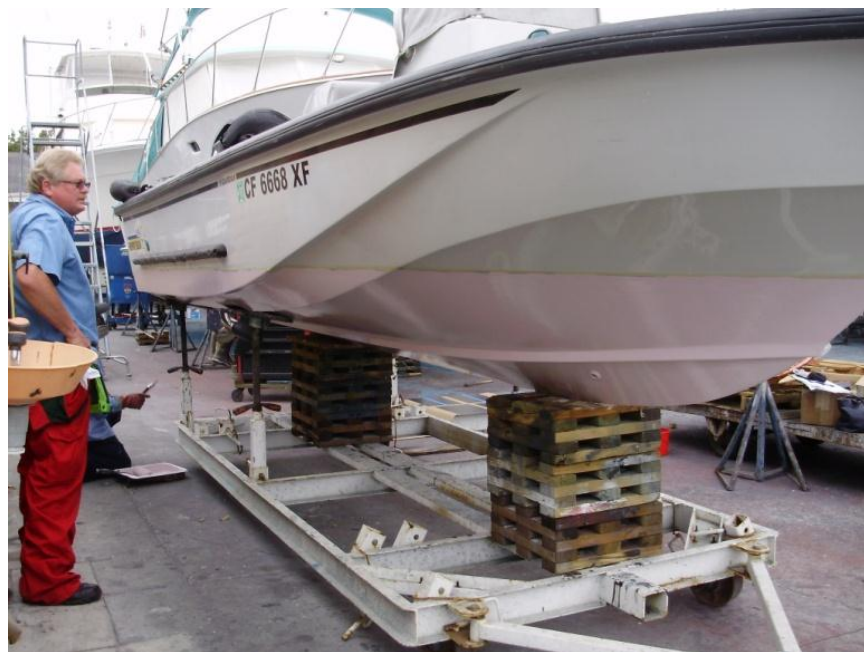
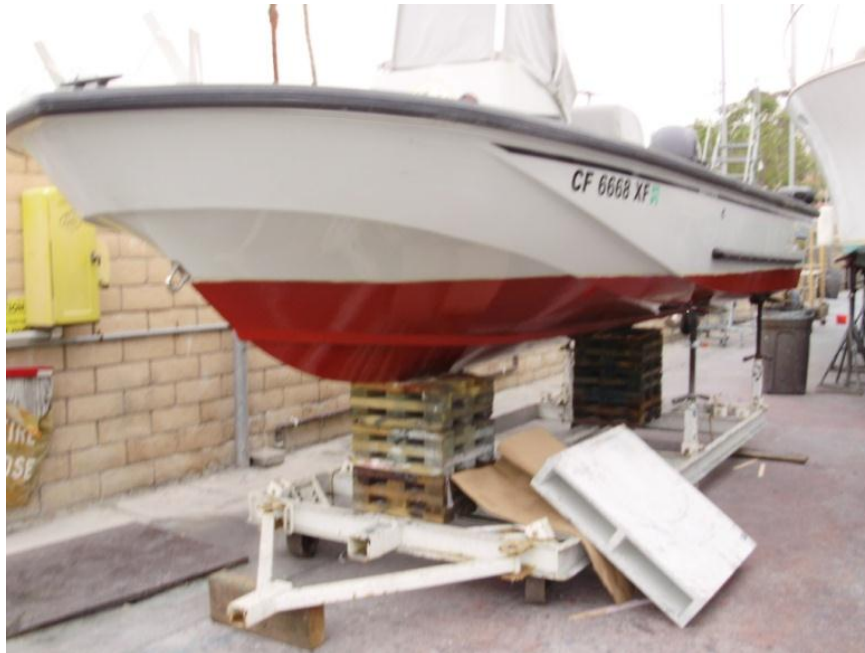
Figure 5-13. City of Newport Beach Boat After Tiecoat Application

Boats are generally put on blocks when the bottom paint is applied. These are supports that are removed when the paint job is completed. Figures 5-13 and 5-14 clearly show the blocks in two locations on the boat bottom for this case. When the paint is cured, the blocks are moved and the spots under the blocks must then be painted, often a day or so later. In this case, there was no additional XA

Figure 5-14. City of Newport Beach Boat After Topcoat Application

The Orange County Coastkeeper inspected the bottom of the boat and videotaped the hull. There were spots where the paint was peeling and they seemed to be in the same location as the blocks in Figures 5-13 and 5-14. IRTA has been involved in painting several boats with Hempasil X3 and no peeling of the paint was ever observed. The XA 278 is similar to the Hempasil X3 and would not be expected to peel. In contrast, the XZM 480 paint on the Fish & Game boat, as described below, was also peeling in some spots. It seems reasonable to assume that the XA 278 paint is performing well and that the peeling spots on the hull are attributable to the XZM 480 applied under the blocks.

278 paint to apply to the boat under the blocks. IRTA was involved in painting another boat at the boatyard at the same time (see Fish & Game—XZM 480 Plus Hardener below) and both paints were similar red colors. IRTA did not want the boatyard to apply copper paint to the spots so the XZM 480 plus hardener coating was applied instead.

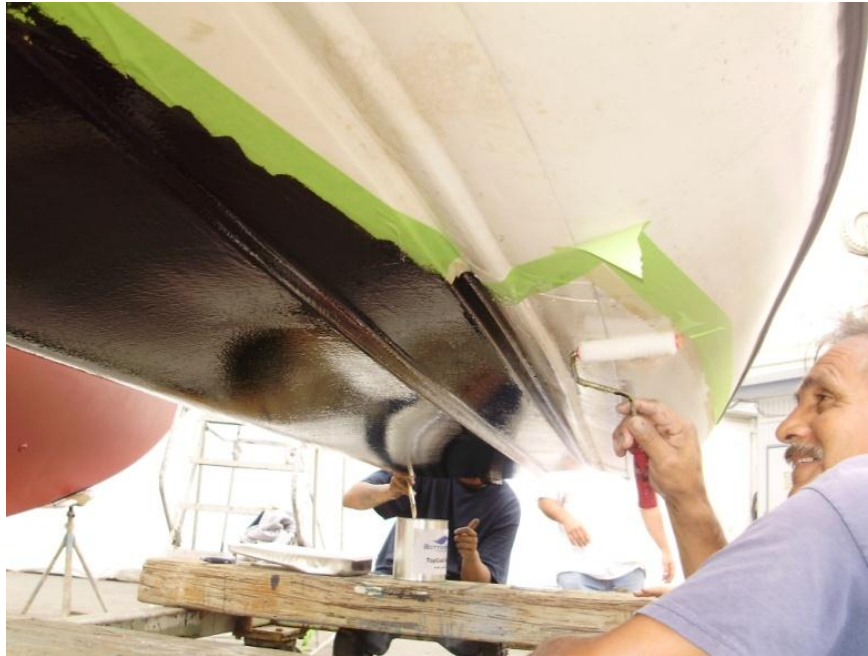
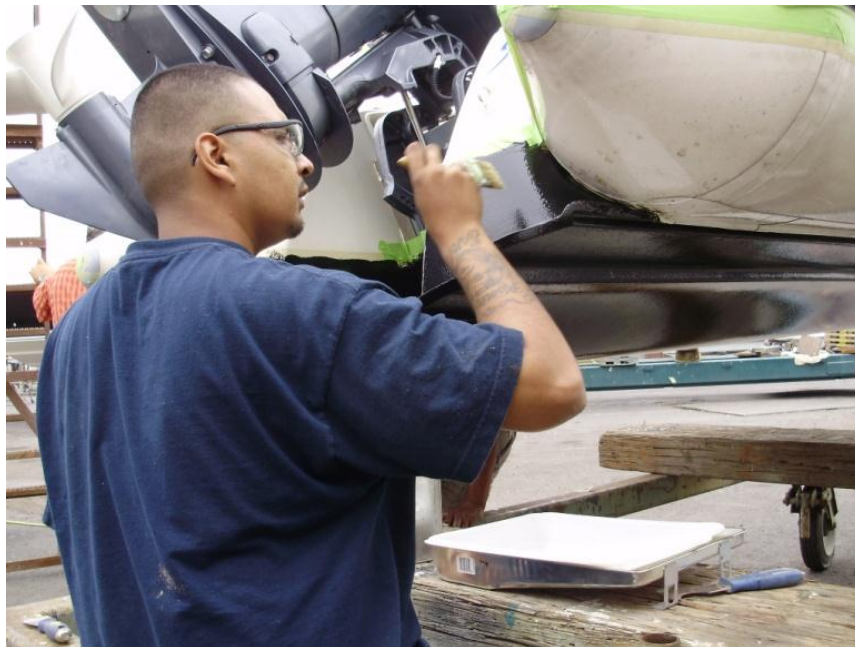
Figure 5-21. Painter Applying Paint to Pasha Boat

Figure 5-22 Painter Applying Paint to Back of Pasha Boat

Since June, the boat was out of the water for a few months. The diver did indicate that the coating seemed to be flaking from one small spot on the rubber. It appeared that the coating may have failed on this one spot when the inflatable rubber was deflated and inflated again. The BottomSpeed coating may not have been fully cured when the boat was launched and this may have also contributed to the flaking. Overall, both the diver and the boat owner indicated the paint was performing extremely well.

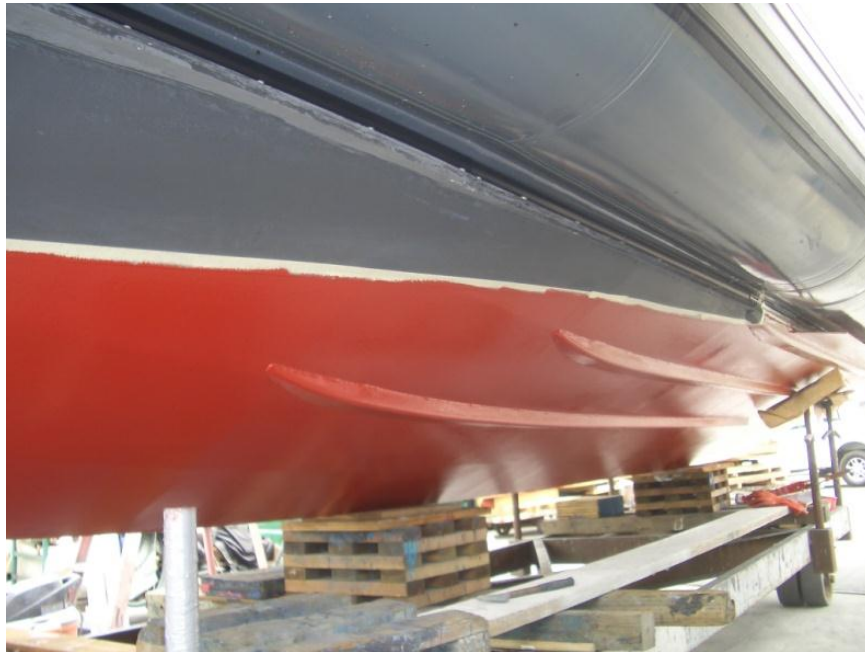
Figure 5-23. Fish & Game Boat After Paint Application

IRTA and the supplier suggested the boat hull be cleaned with a terry towel and the diver did clean the boat on August 10. At that stage, the hull was observed to be relatively clean. The boat driver did observe that the paint did not adhere well to the rudders of the outboard and was coming off. The rudders are the most highly stressed components on a boat.

The boat was cleaned again in September and the diver observed three spots on the hull where the paint was peeling off. An underwater picture of the hull with the spots where the paint is peeling is shown in Figure 5-24. Another underwater picture of peeling paint in a different hull location is shown in Figure 5.25. According to the diver, one of the spots was a result of wax paper being removed during the paint job; paint was pulled off with the paper. The diver could initially see some wax paper on the
